Mr. D K Taneja
Insurance Consultant,
M/s Maja Industries, Plot No. 160-161-162,
SICOP Industrial Estate, Kathua, J&K

Sub: Inspection and testing report of fire affected building

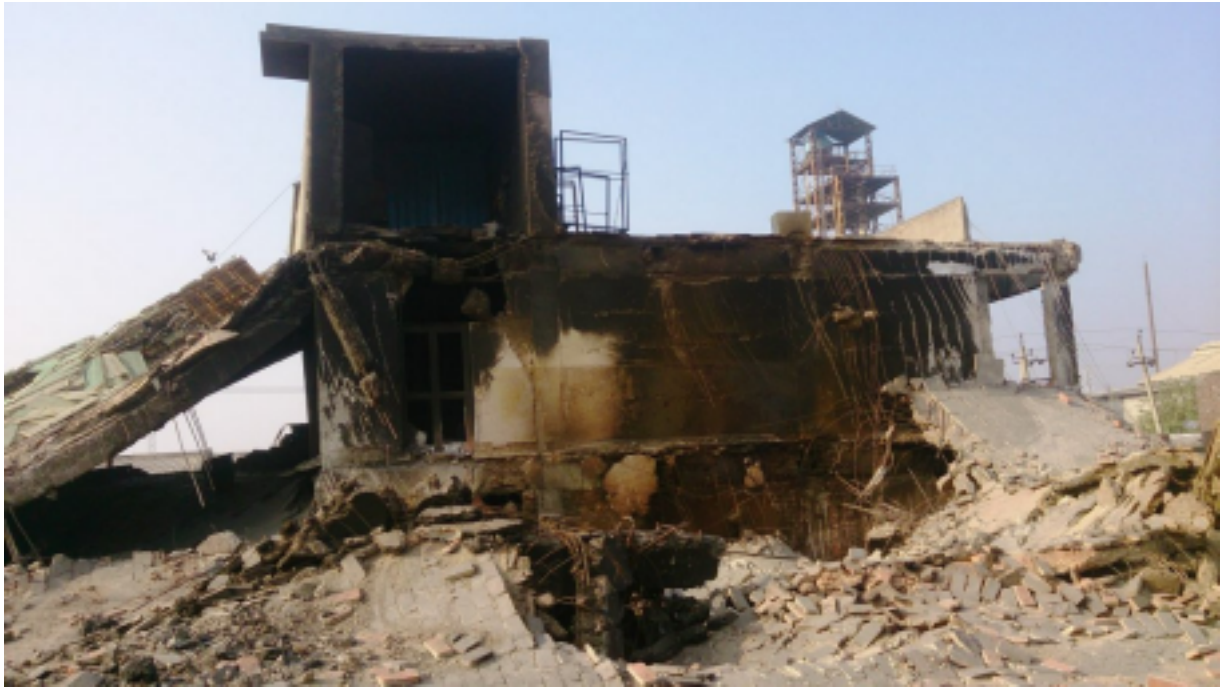
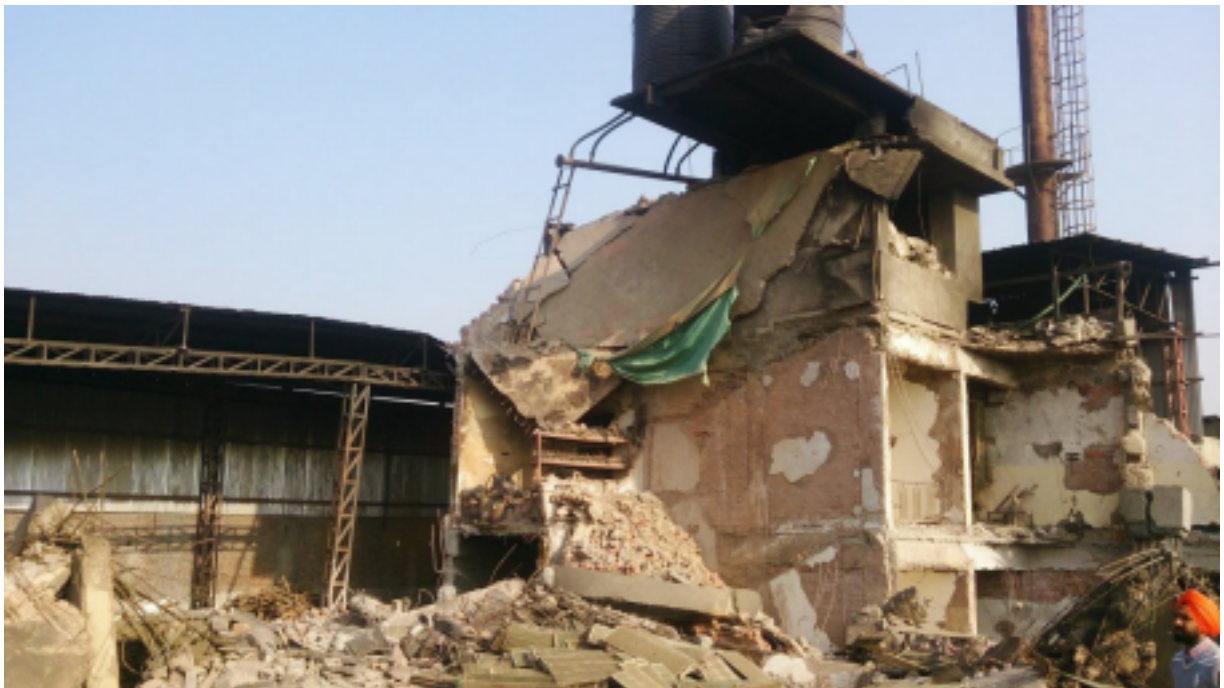
- i) The intensity of fire in the rear portion of the building seemed to be very high, whereby high temperatures badly affected the capacities of both concrete and steel, which led to its ultimate collapse. The front portion of the building which didn't bore the direct brunt of the fire – due to its insulation from the rear portion by brick wall – escaped the collapse but was subjected to stresses due to collapse of the adjacent portion, which led to development of widespread cracks in it, thereby making it unfit for its intended use.

Collapsed structure

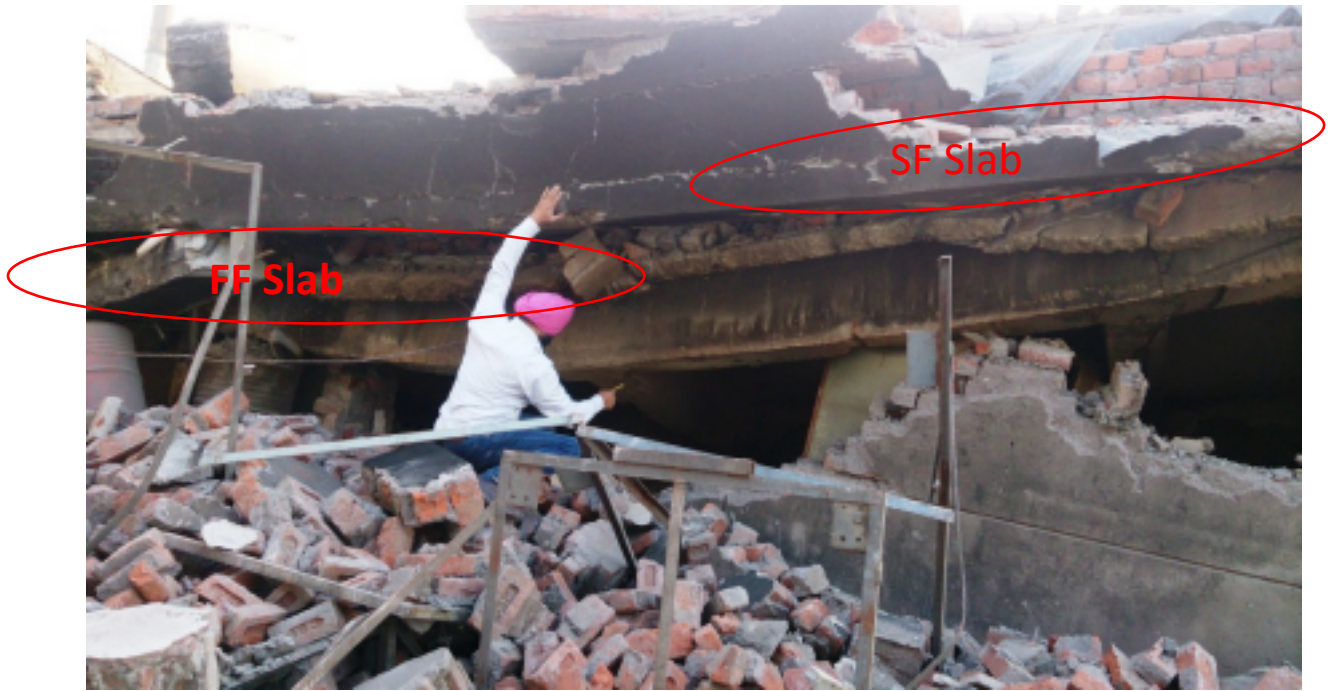
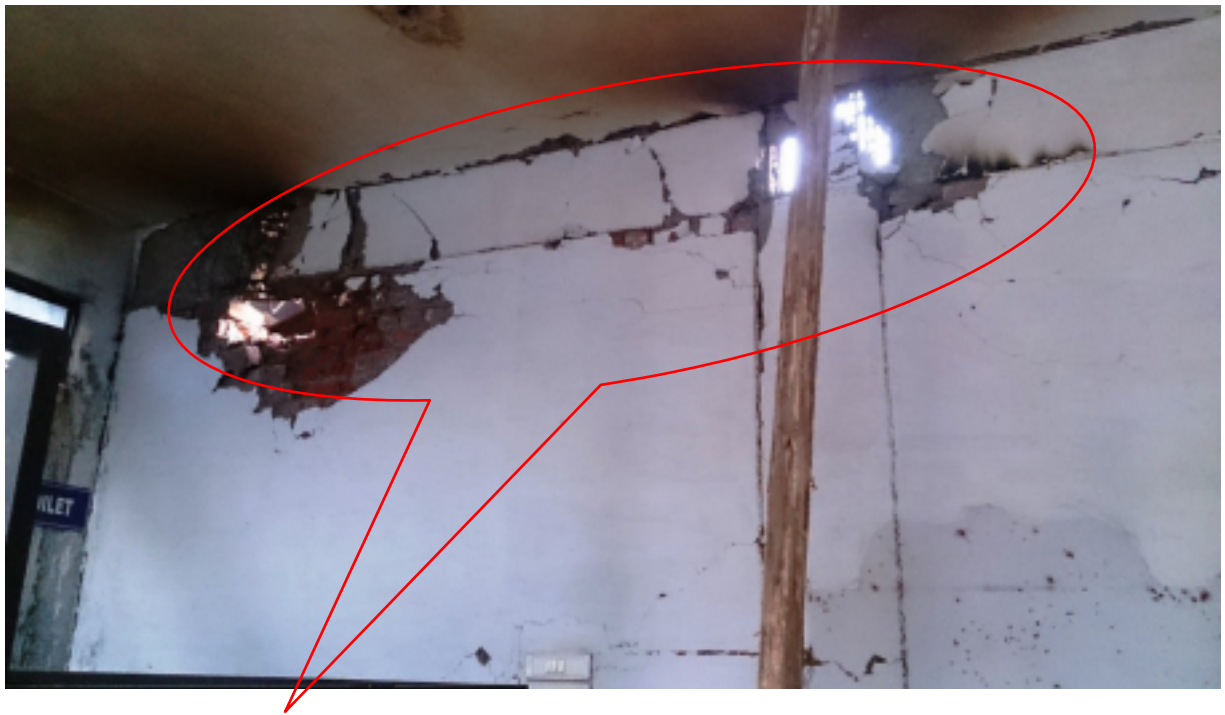
Cracks and spalling of concrete in the front portion of the building

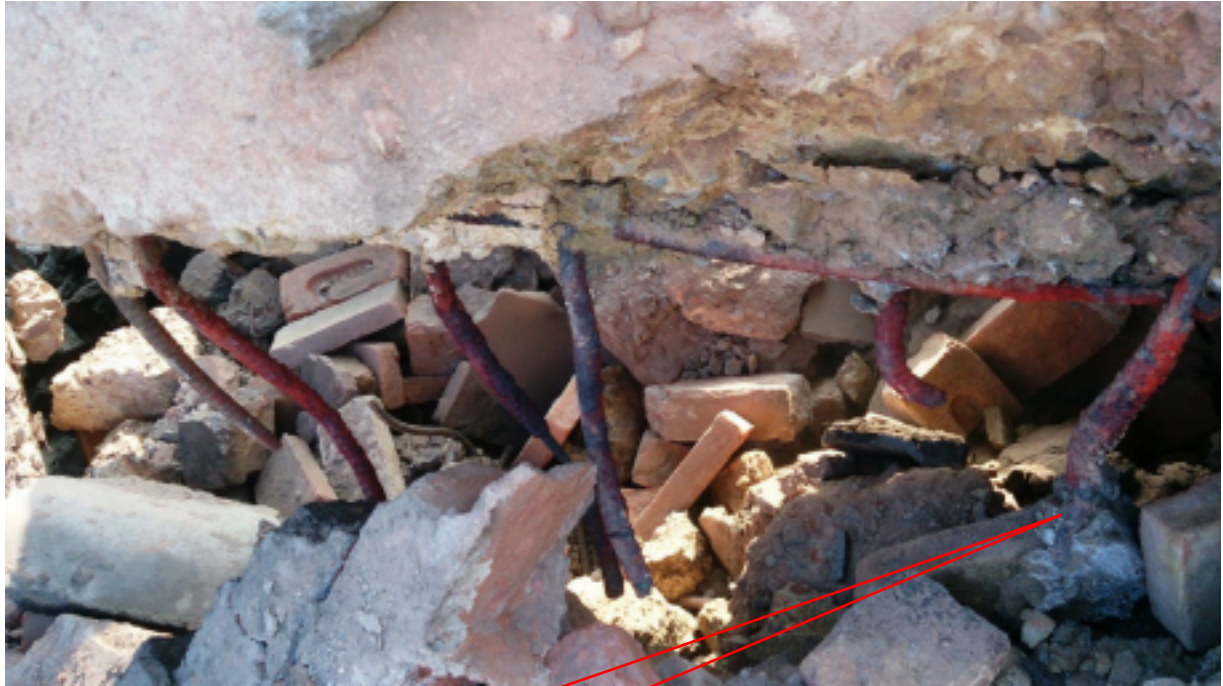
- ii) The effect of fire and heat was evident everywhere on all components of the structure, whereby the colour of concrete had turned 'ash grey' and its texture had 'softened'. Similarly, the rebars showed the sign of extreme heat as it had melted and cracked at some of the locations.

Rebar melted

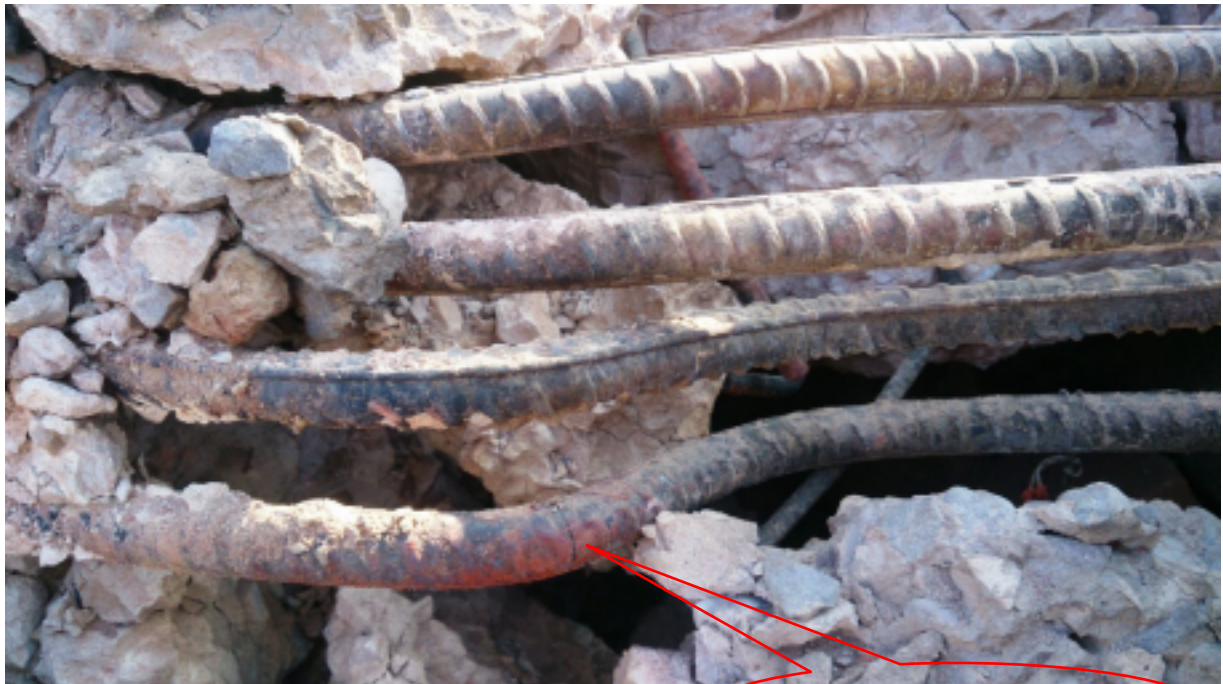
Crack in Rebar

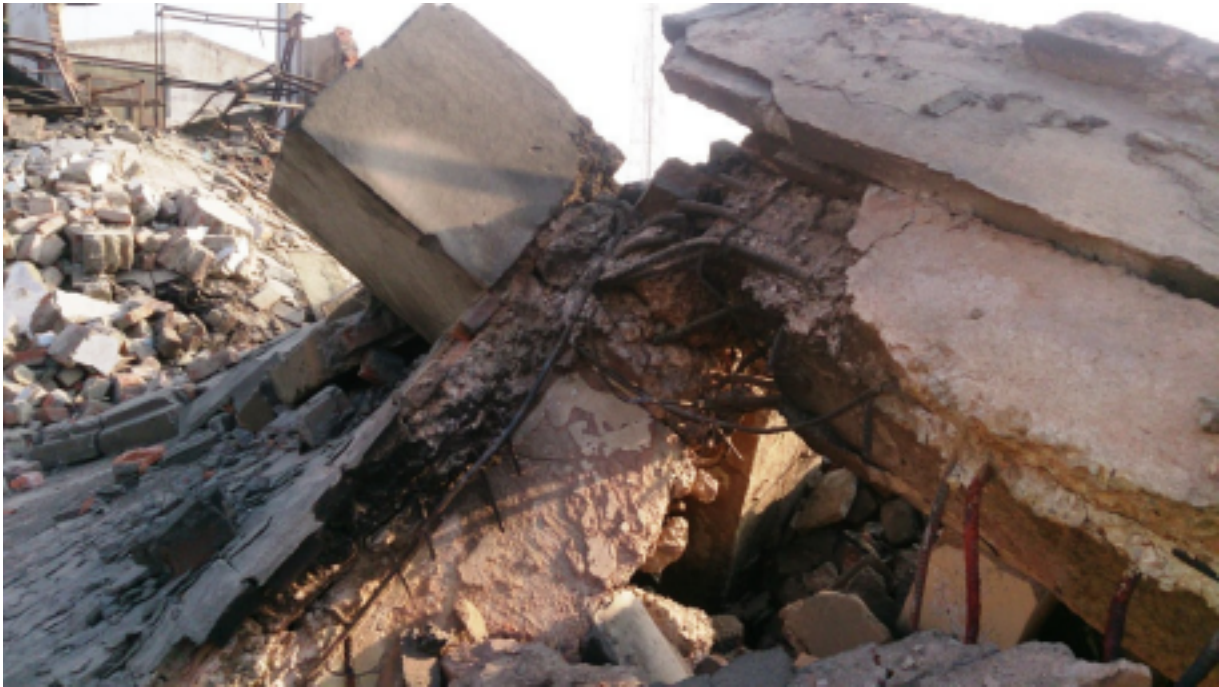
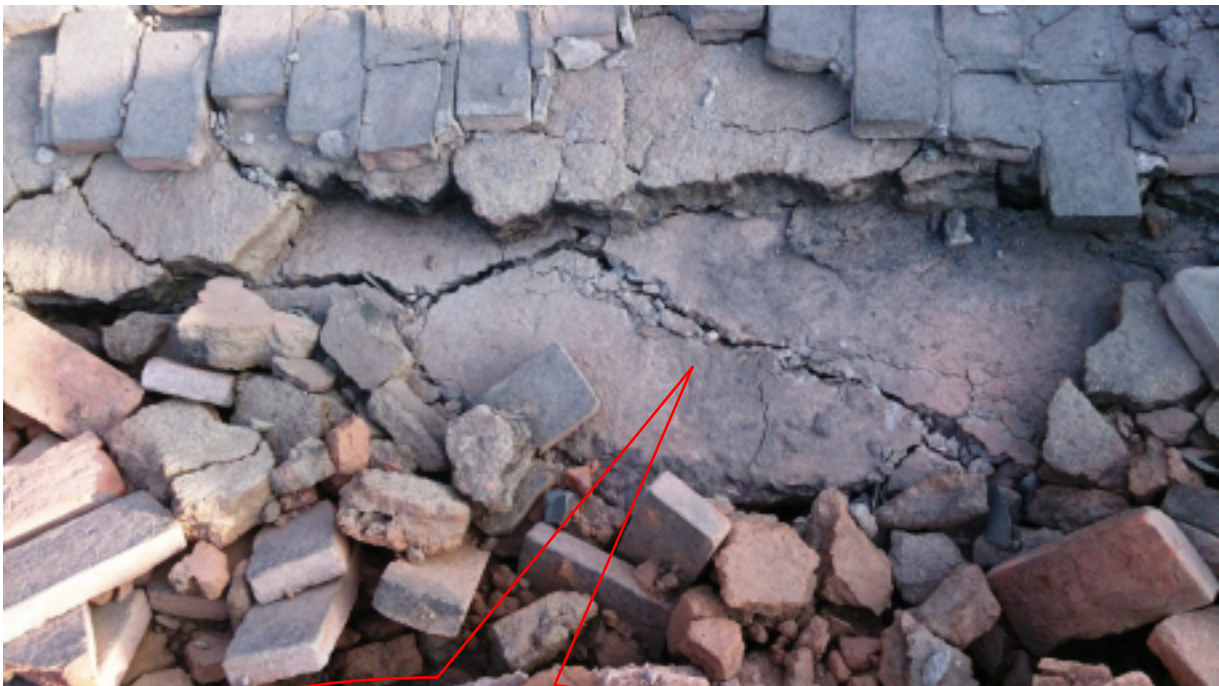
**Softened concrete in
the slab**

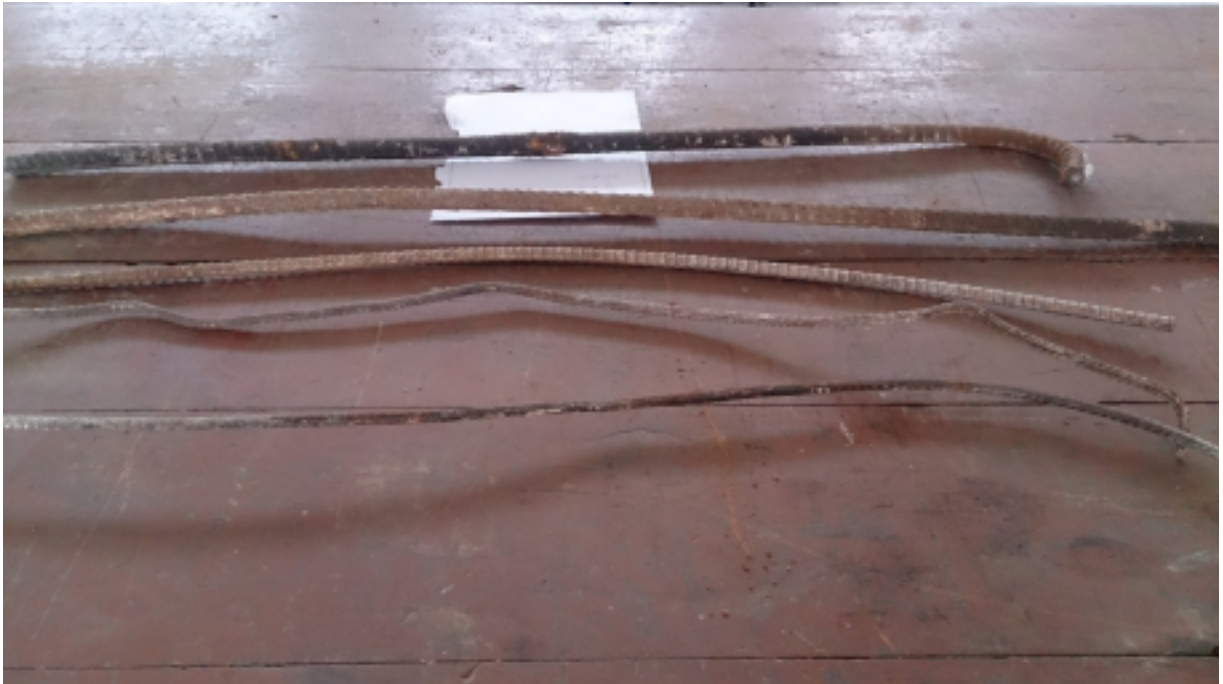
Rebar samples were checked and collected from site to ascertain their quality in the laboratory. These rebar samples did not contain any brand name – which is normally available on every single meter length – and thus did not indicate any information of their make. Reinforcement steel of “KAMDHENU” make was also used in construction. | ?

Following is the test report of various samples as collected from site (shown above), for which ‘make’ was unknown:

The values marked by star (*) do not meet the code specifications for reinforcement steel of grade Fe 415 – lowest available grade (IS 1786: 2008).
