Mr. D K Taneja
Insurance Consultant,
M/s Maja Industries, Plot No. 160-161-162,
SICOP Industrial Estate, Kathua, J&K

Sub: Inspection and testing report of fire affected building

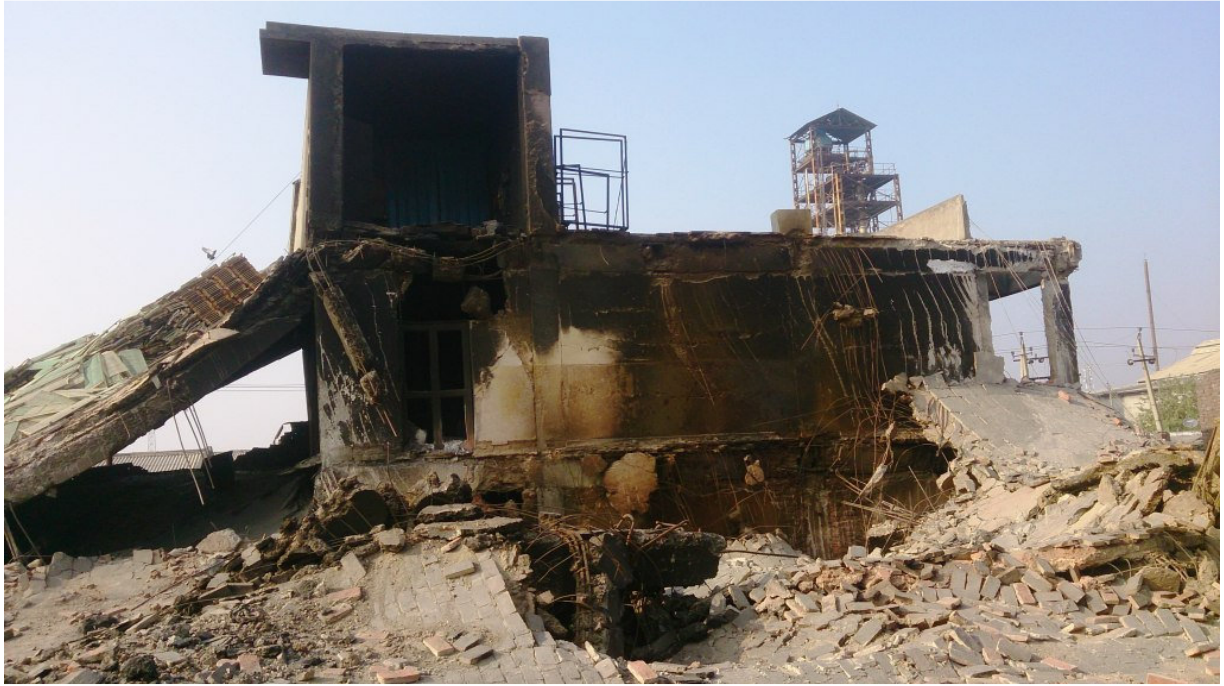
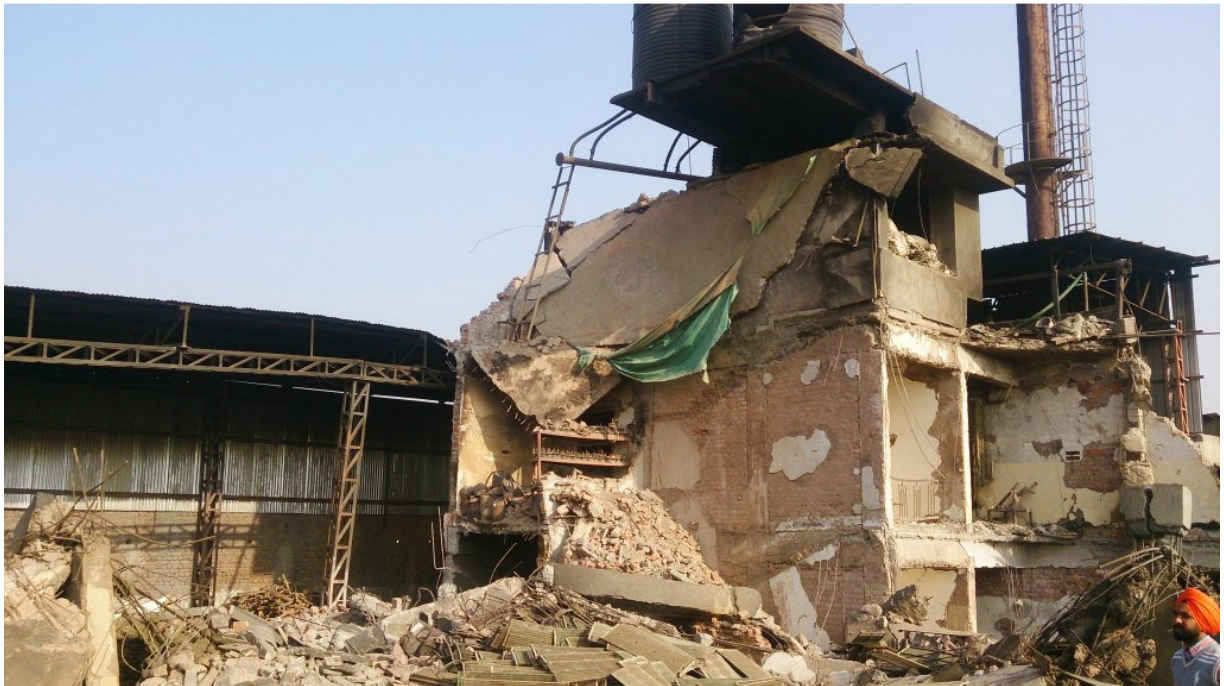
- i) The intensity of fire in the rear portion of the building seemed to be very high, whereby high temperatures badly affected the capacities of both concrete and steel, which led to its ultimate collapse. The front portion of the building which didn't bore the direct brunt of the fire – due to its insulation from the rear portion by brick wall – escaped the collapse but was subjected to stresses due to collapse of the adjacent portion, which led to development of widespread cracks in it, thereby making it unfit for its intended use.

Collapsed structure

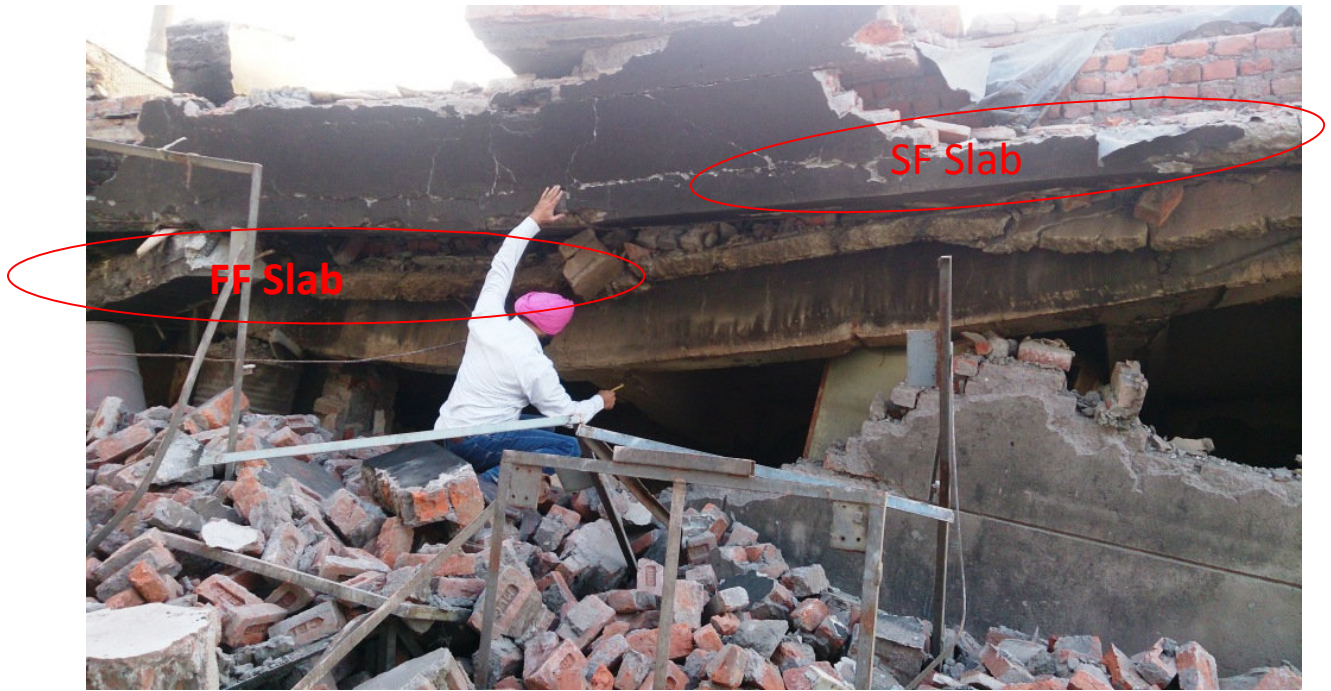
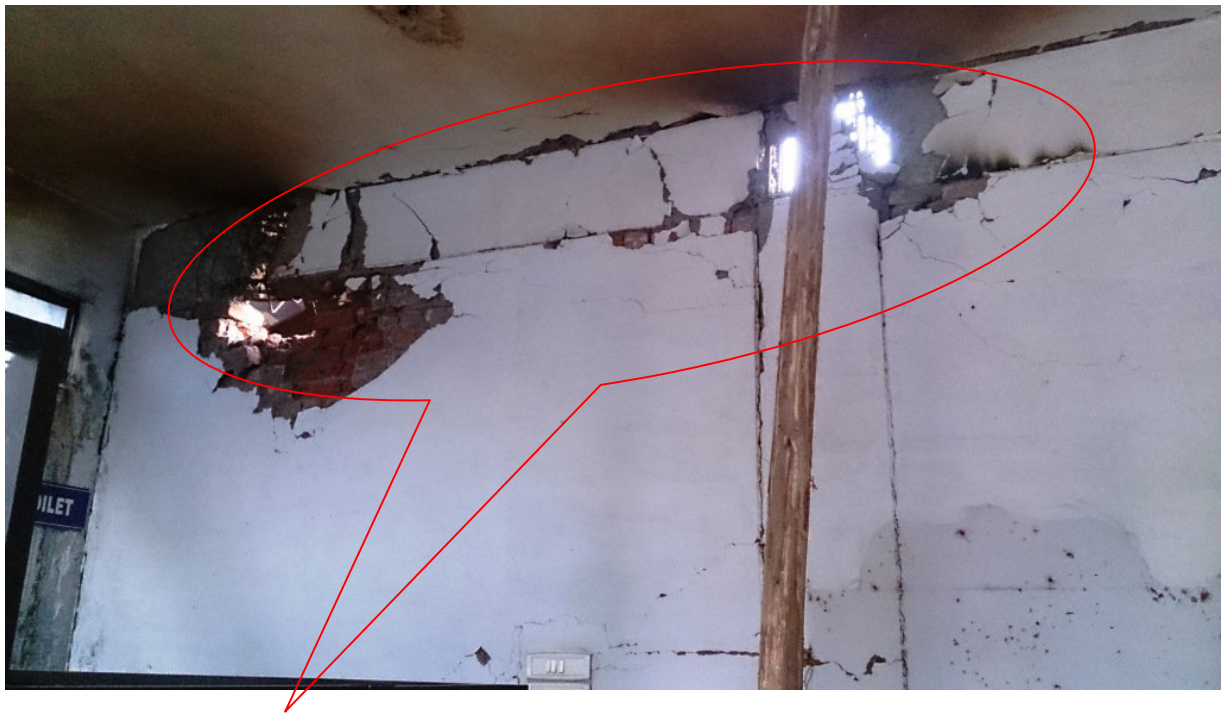
Cracks and spalling of concrete in the front portion of the building

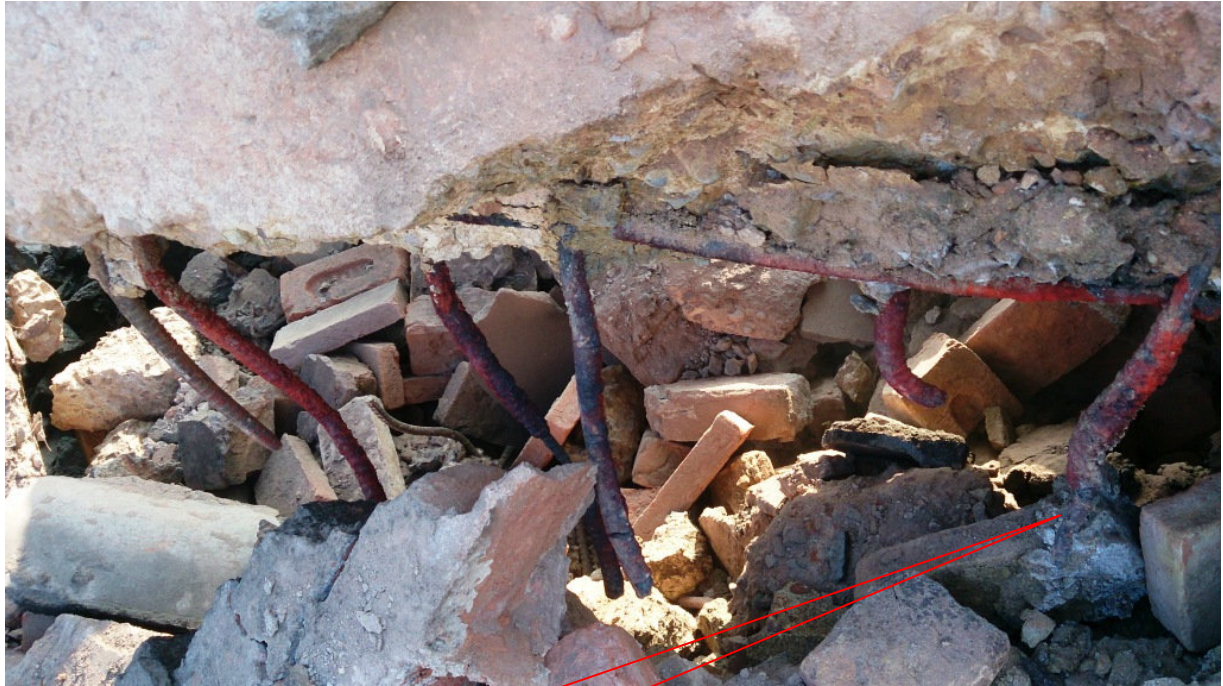
- ii) The effect of fire and heat was evident everywhere on all components of the structure, whereby the colour of concrete had turned 'ash grey' and its texture had 'softened'. Similarly, the rebars showed the sign of extreme heat as it had melted and cracked at some of the locations.

Rebar melted

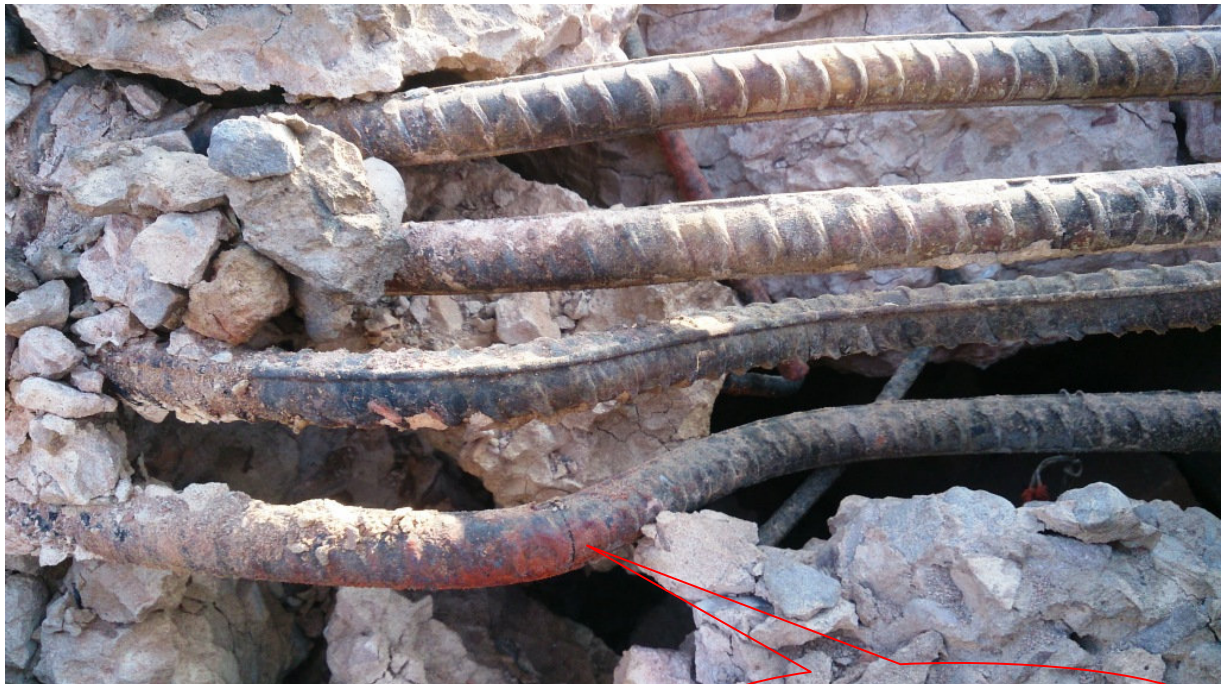
Crack in Rebar

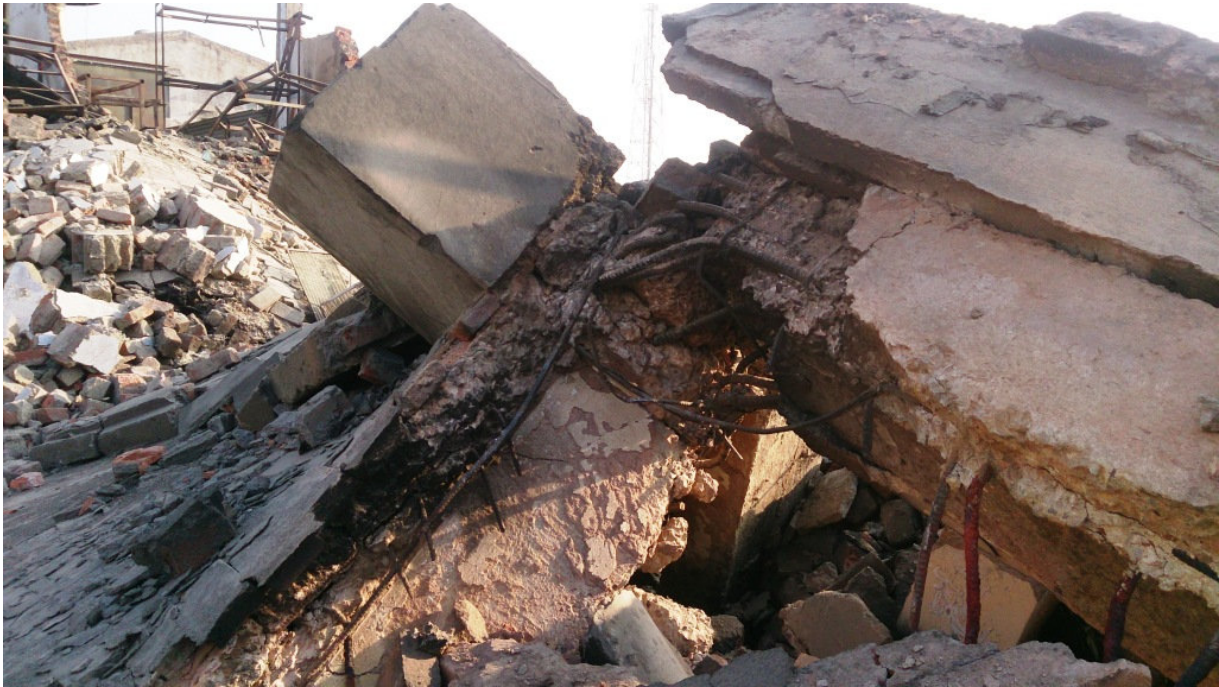
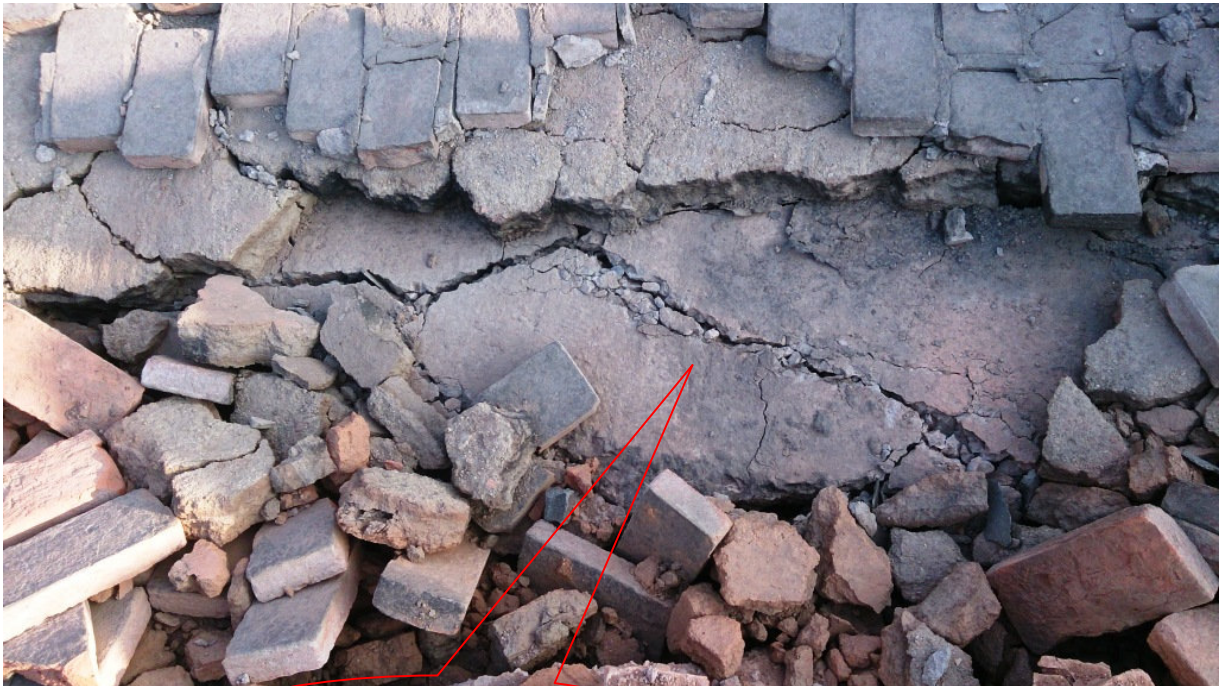
**Softened concrete in
the slab**

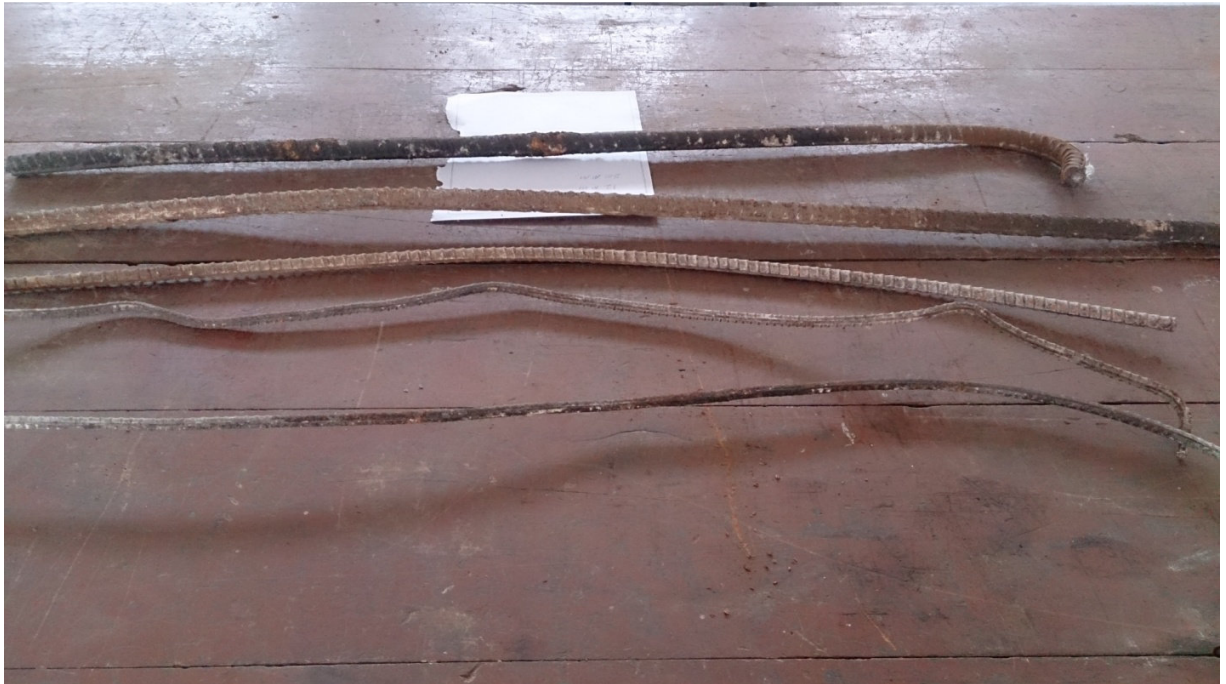
Rebar samples were checked and collected from site to ascertain their quality in the laboratory. These rebar samples did not contain any brand name – which is normally available on every single meter length – and thus did not indicate any information of their make. Reinforcement steel of “KAMDHENU” make was also used in construction.

Following is the test report of various samples as collected from site (shown above), for which ‘make’ was unknown:

The values marked by star (*) do not meet the code specifications for reinforcement steel of grade Fe 415 – lowest available grade (IS 1786: 2008).
