## CHAPTER-5

### ANALYSIS OF RESULTS AND DISCUSSION

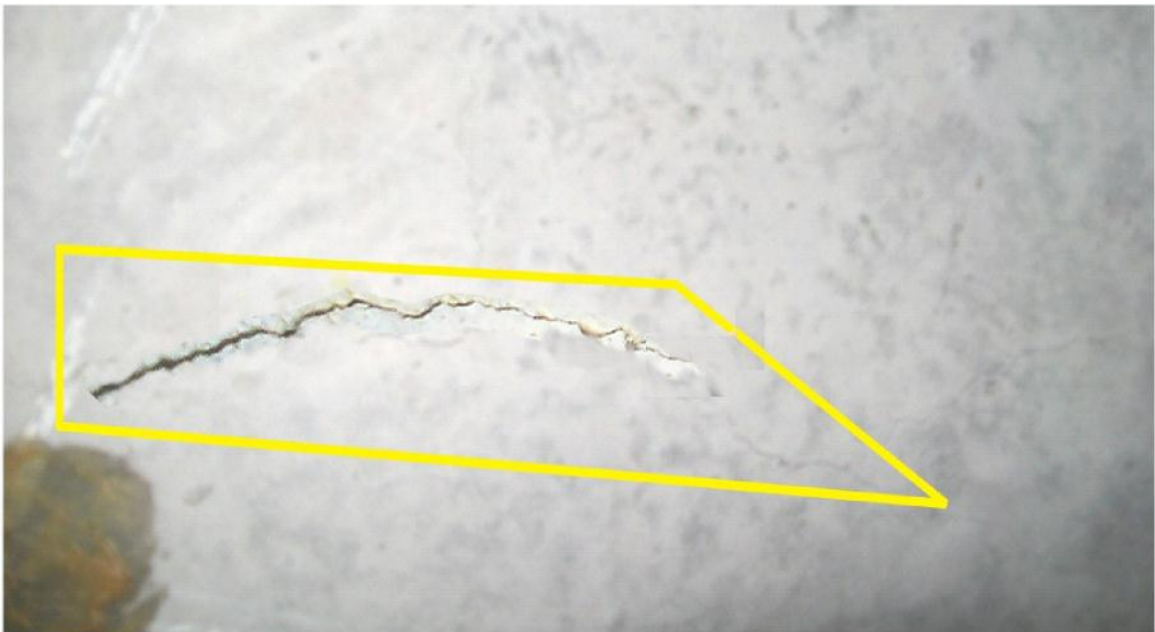
**Fig. 5.1: Initiation of cracks in slabs (typical)**

Subsequently, the slabs were intentionally damaged under uniformly distributed load in the loading arrangement of the heavy testing laboratory of Civil Engineering Department of Guru Nanak Dev Engineering College. The load was applied and the corresponding central deflection was observed at each  $5 \text{ kN}$  interval (equivalent to  $1.21 \text{ kN/mm}^2$  for S1 slabs specimens and  $1.35 \text{ kN/mm}^2$  for S2 slabs specimens). In all the slabs, almost uniform crack patterns were observed. Some typical crack patterns obtained are shown in Fig. 5.1-5.4.

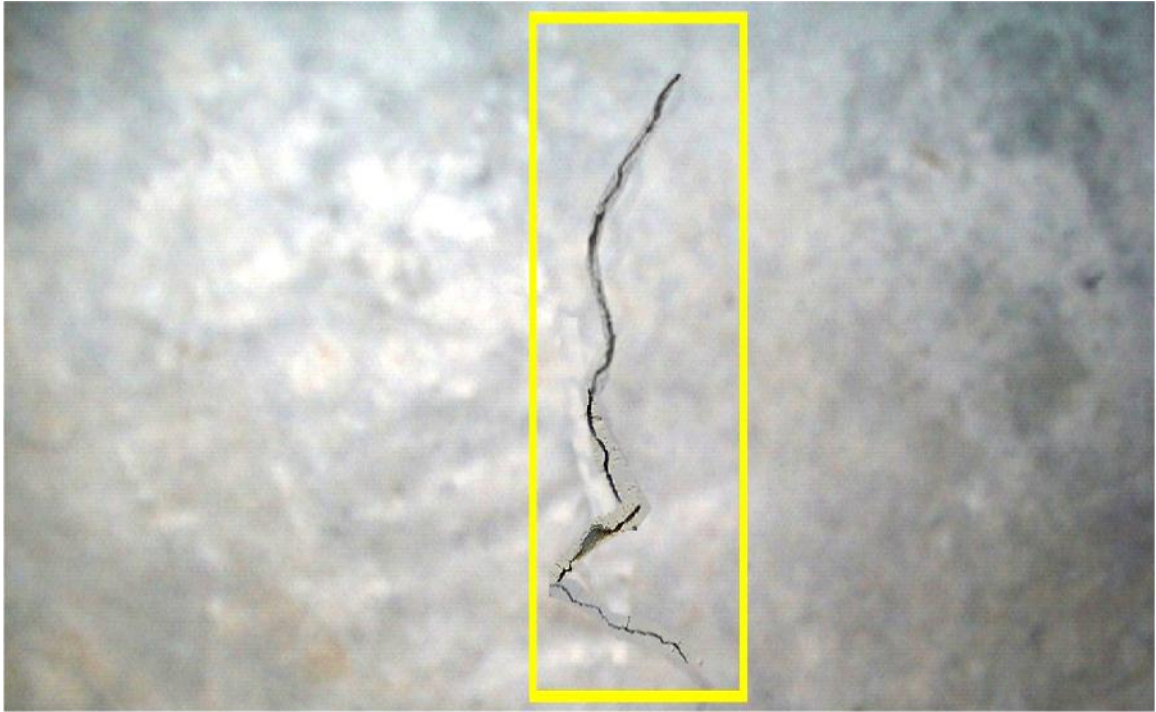
**Fig. 5.2: Cracks in slabs (typical)**

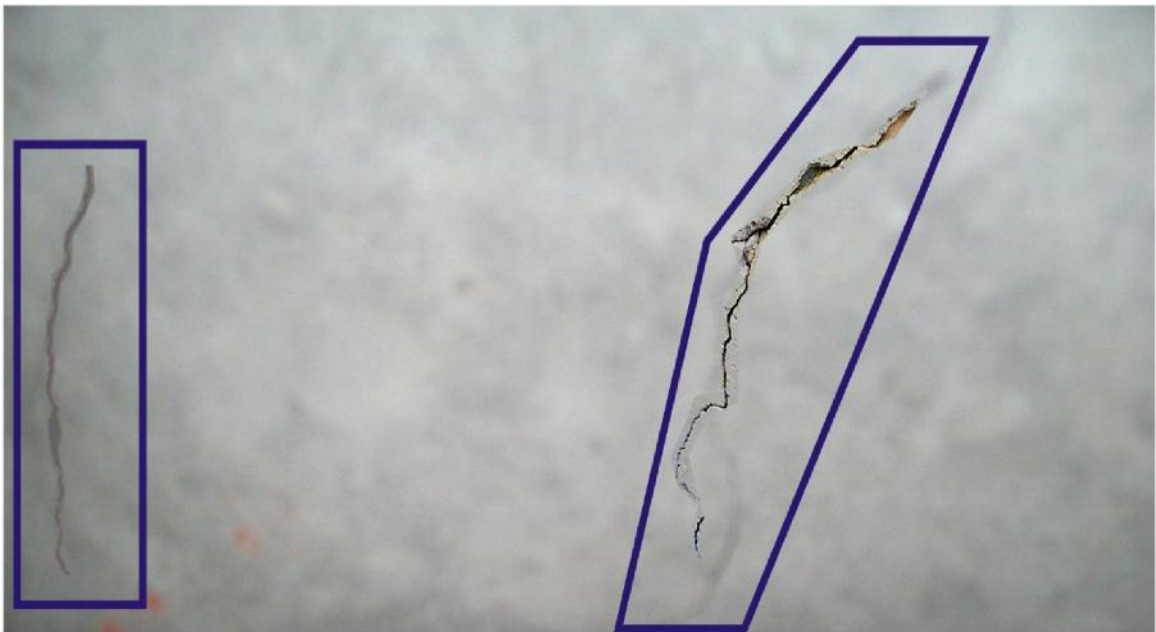
**Fig.5.3: Development of cracks (typical)**

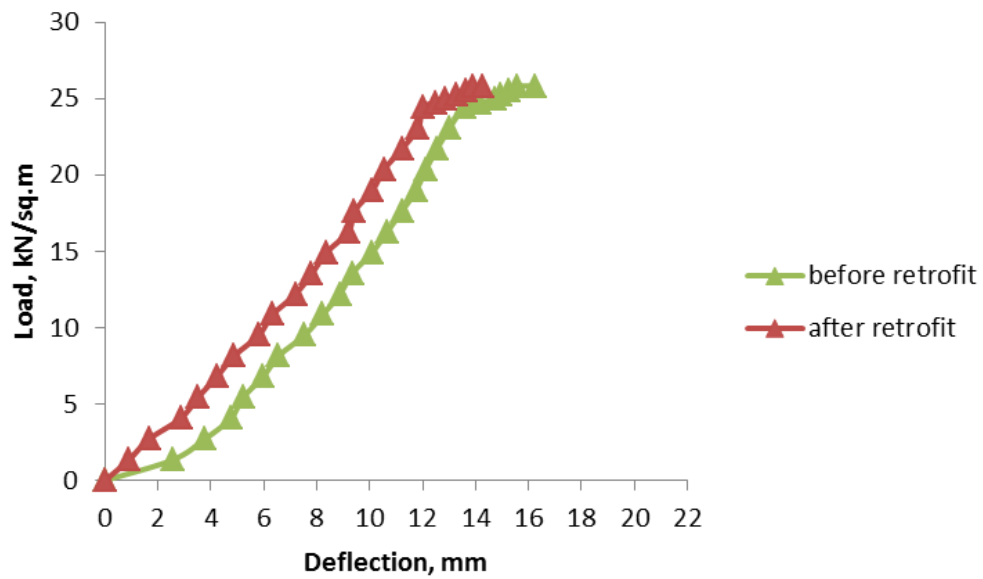
**Fig. 5.10: Load-Deflection curve of slab S23 (before and after MS Plate retrofitting)**

In case of Mild Steel retrofitted slabs S13 and S23 of size S1 and S2, it was observed that the percentage decrease in the deflection was 22% for S13 and 12 % for S23 when the virgin slabs before retrofitting and Mild Steel plate retrofitted slabs were compared

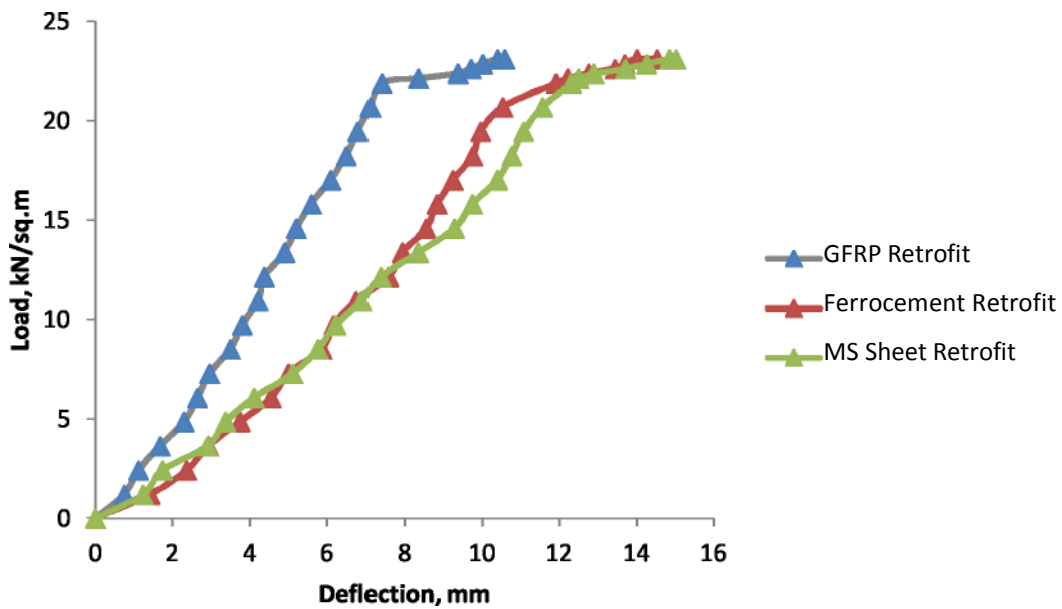
**Fig. 5.11: Load-Deflection curve of S1 slabs retrofitted with different materials**

After retrofitting, the slabs were tested under uniformly distributed load. The load-deflection curves obtained for retrofitted and control slabs are presented in Fig. 5.5-5.10. Their combined load deflection results for S1 and S2 slabs have been shown in the Fig. 5.11 and Fig. 5.12.

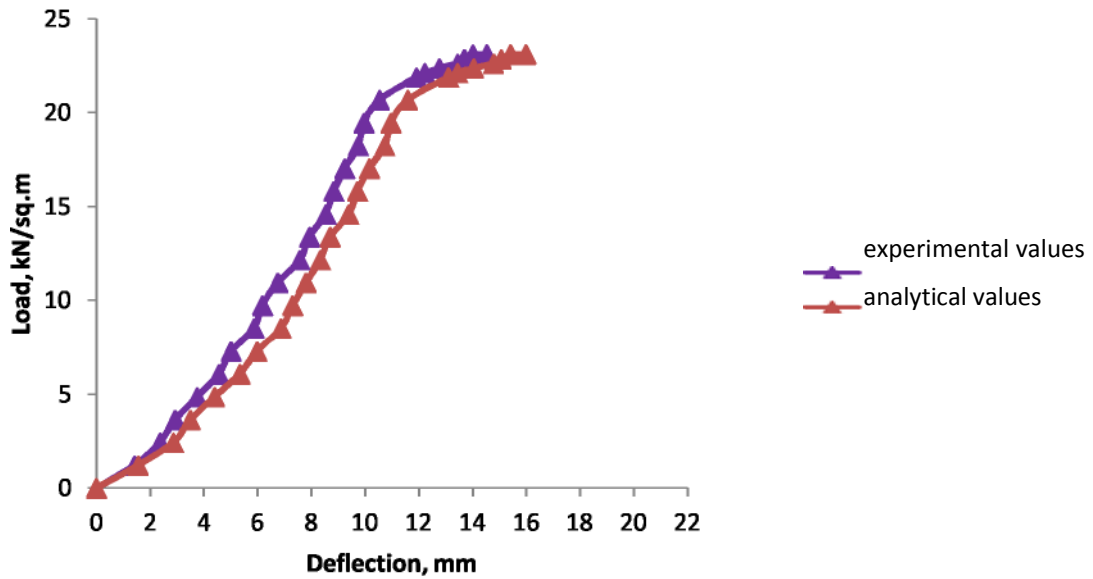
**Fig. 5.17 Analytical and Experimental Load-Deflection values of Ferrocement retrofit Slab S12**

that the analytical values as seen from Fig. 5.13 to 5.22 were in good agreement with the numerical values (within  $\pm 5\%$ ). This confirmed the numerical validation on the slabs.

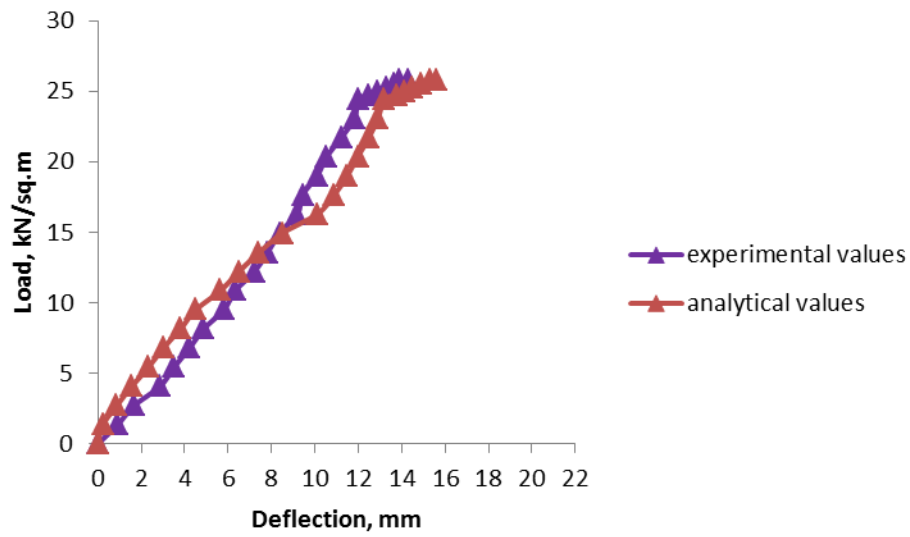
**Fig. 5.20: Analytical and Experimental Load-Deflection values of MS Plate retrofit slab S23**

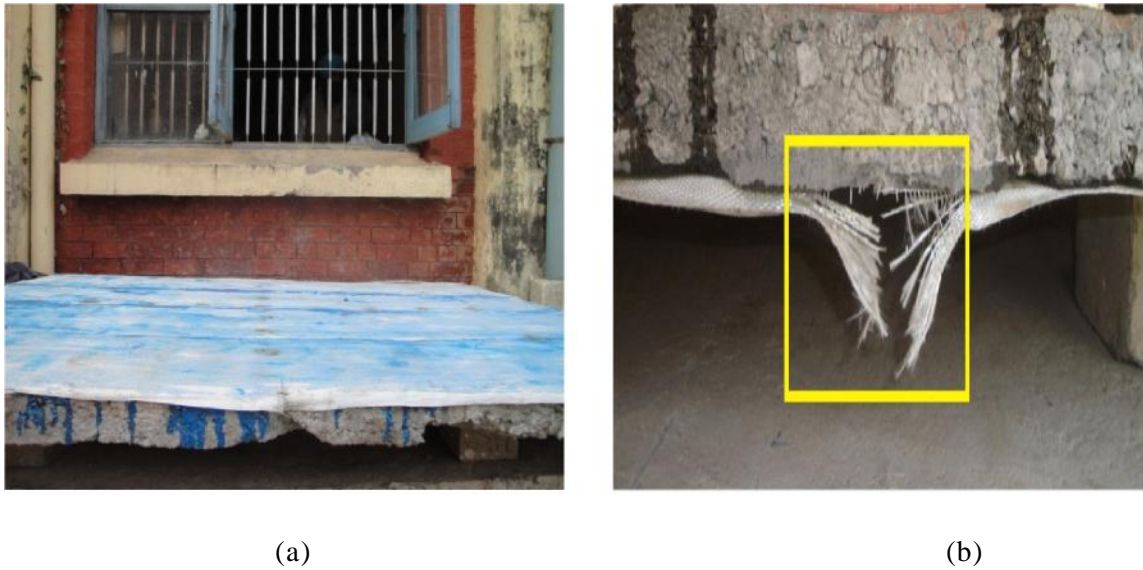
**Fig.5.23: Debonding of GFRP in Slab (typical).**

It was observed that the major failure through which the slabs underwent was the debonding failure. In all the retrofitted slabs, almost uniform crack patterns and failure patterns were observed. Some typical crack and failure patterns obtained are shown in Fig. 5.23-5.29.

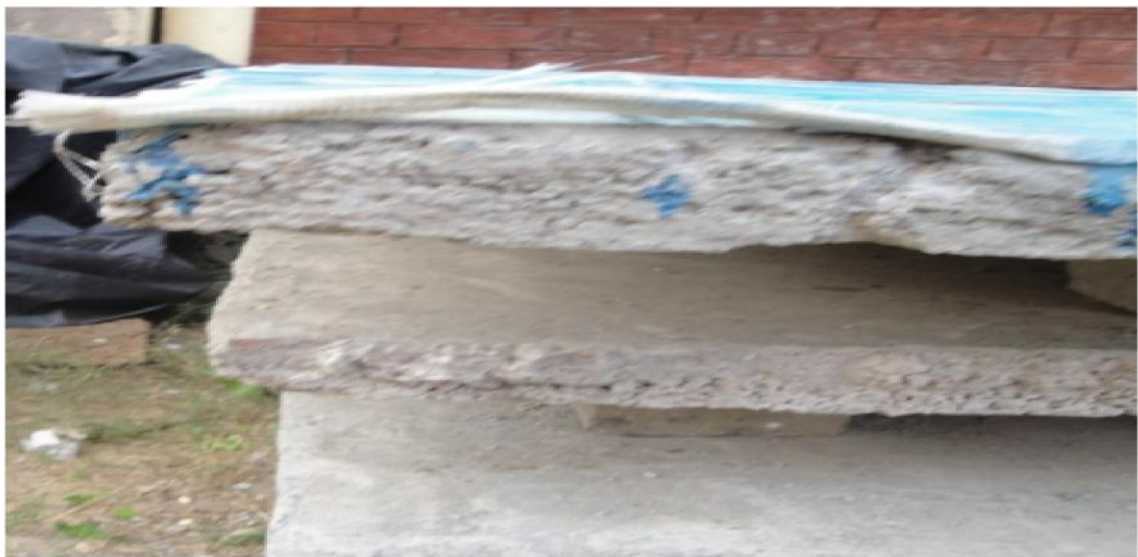
**Fig.5.24: Debonding of GFRP at Corners (typical).**

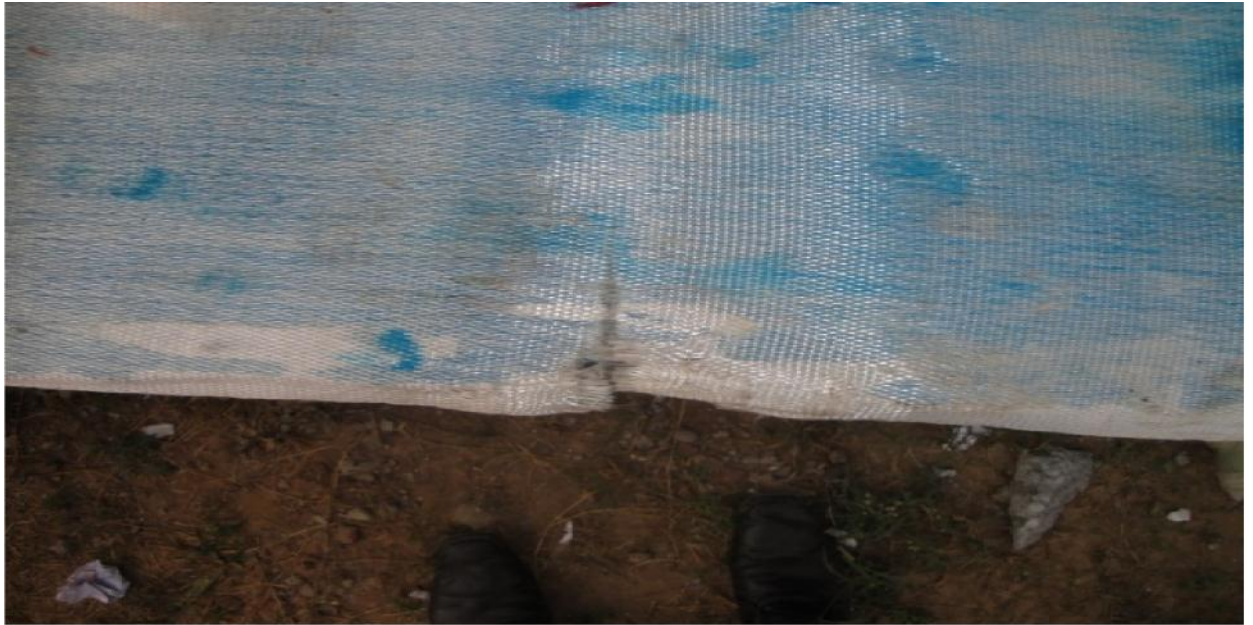
**Fig. 5.25: GFRP failure pattern followed similar trend on other side of the slab (typical)**

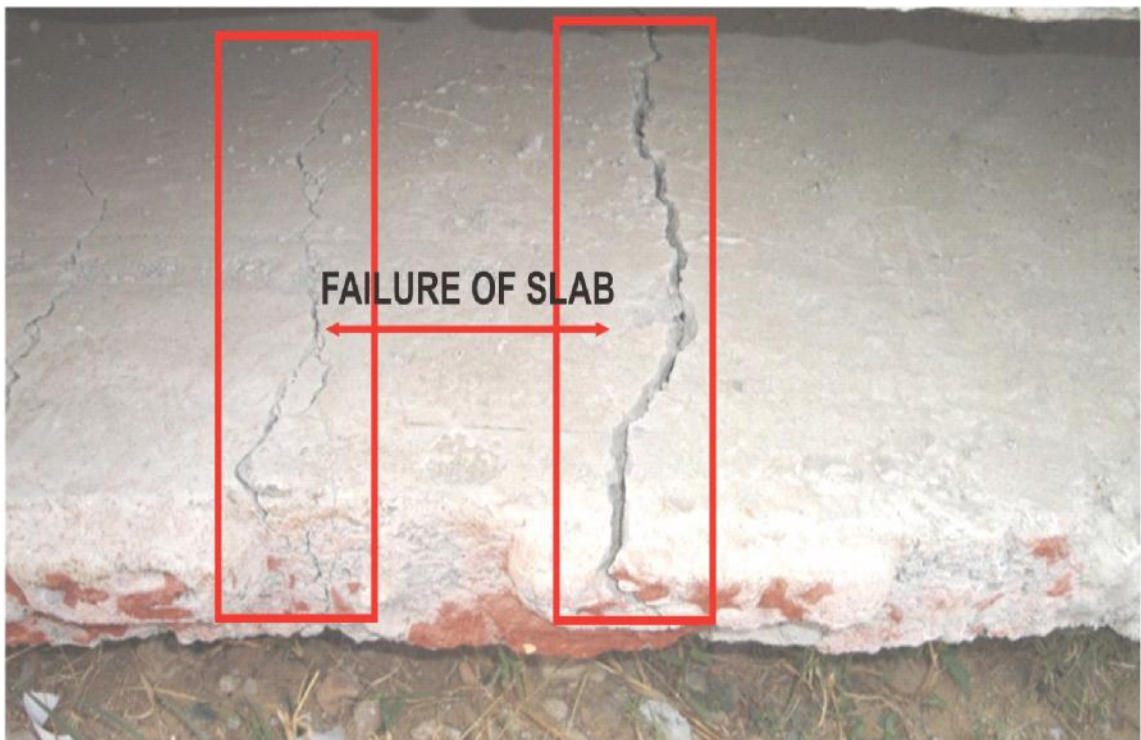
**Fig.5.26: Failure pattern of slab retrofitted with Ferrocement (typical)**

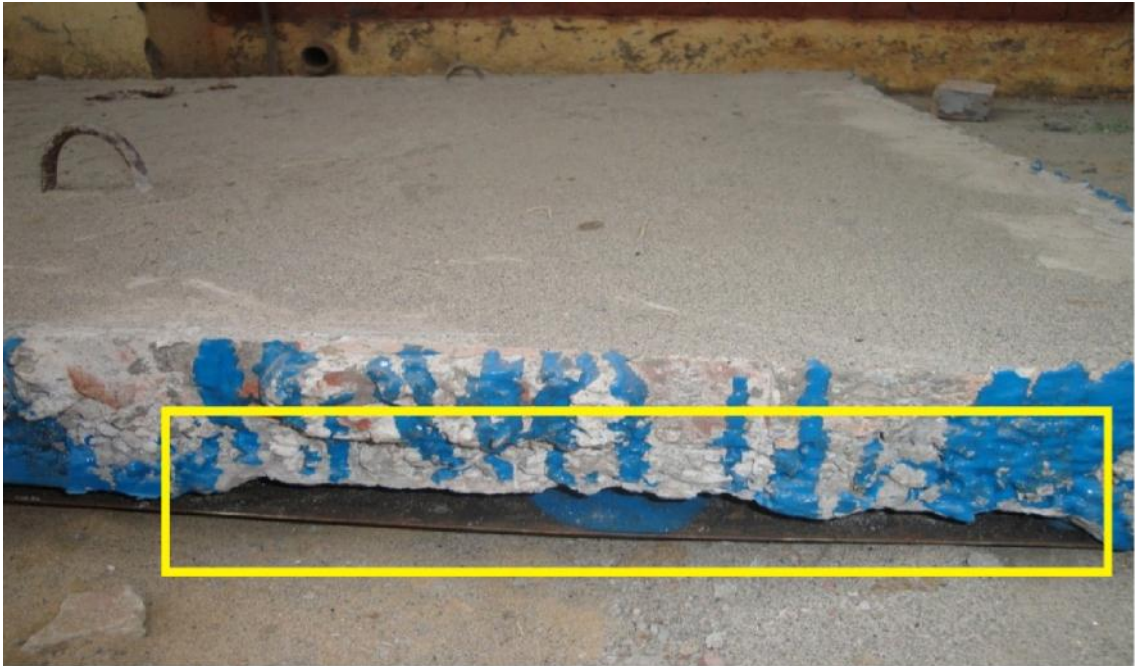
**Fig.5.27: Debonding of MS Plate (typical)**

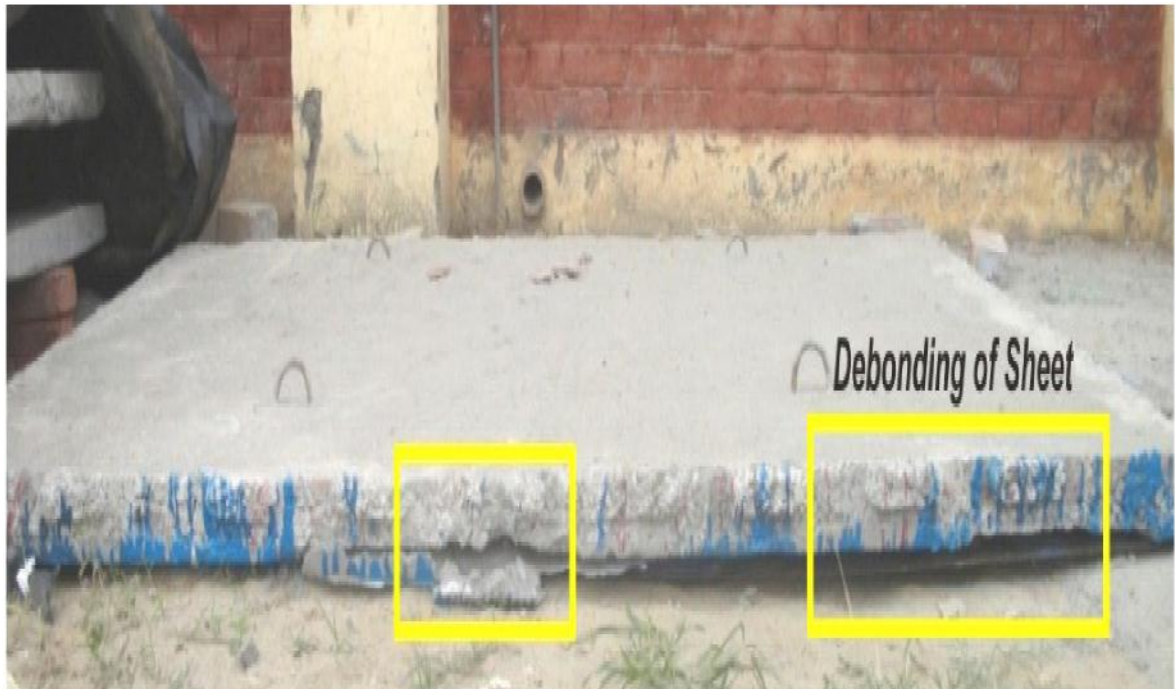
**Fig.5.29: Complete Split-up of MS Plate (typical)**

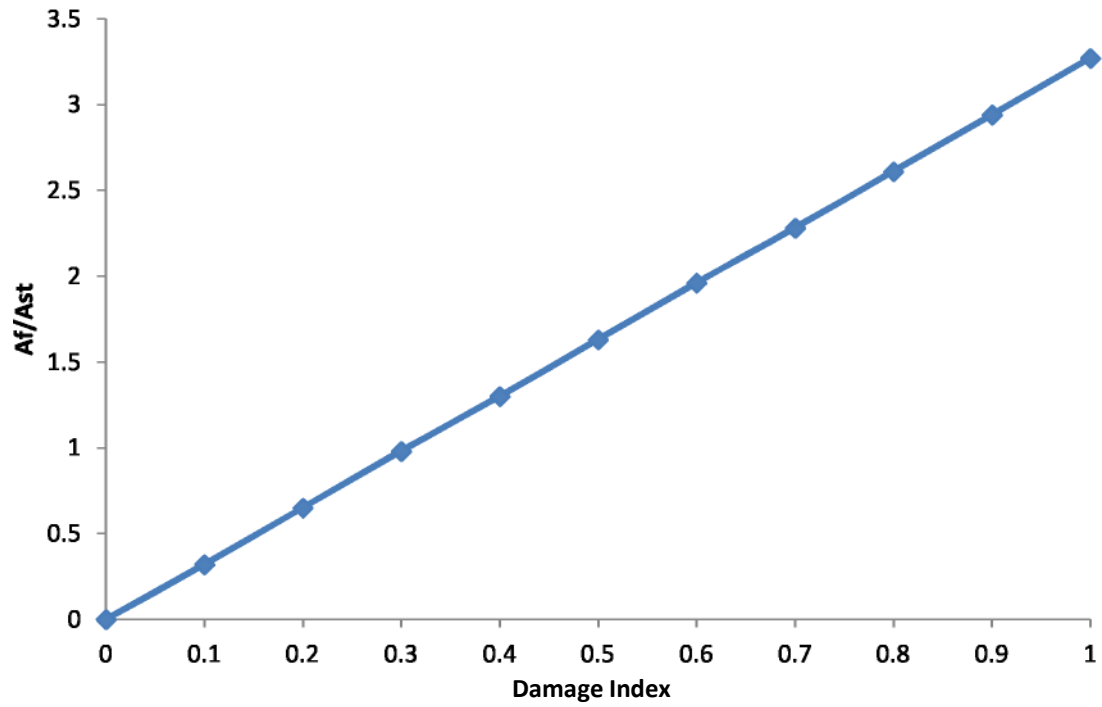
**Fig. 5.31: Relation between damage index and ratio of areas for GFRP retrofitted slab**

As the damage index range between 0 and 1, substituting the values of D.I in equal increment of 0.1 from 0 up to 1, we get the curve as shown in Fig. 5.31. From this curve, the area of fibres can be found out from the already known value area of reinforcement and the design of the retrofit system can be made.

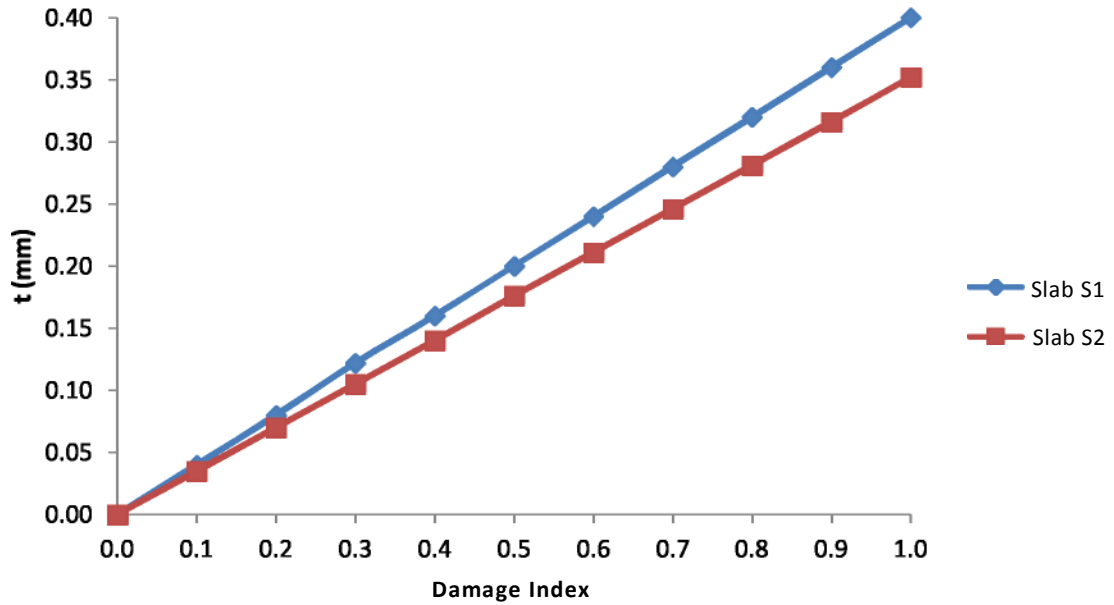
**Fig. 5.33: Relation between Damage Index and Thickness (t) of Mild Steel Plate.**

Likewise, the design of slab with Mild Steel as a retrofitting material can be made from the Fig. 5.33 between thickness of Mild Steel Plate ( $t$ ) and Damage Index (The detailed explanation is given in *Annexure-1*).
